**Flood Control Project Maintenance
Levee Inspections**

Fall 2015 Levee Maintenance Deficiency Summary Report

Levee District No. 0001 (Glenn County)

Waterway			Bank	Unit Miles
Unit No. 01 Sacramento River			Right	12.23
	Spring (March - May)	Summer (June - August)	(September - November) Fall	Winter (December - February)
Unit Maintenance Rating (Fall Only)			M	
Date of Inspection	04/07/2015 - 04/07/2015		09/14/2015 - 09/14/2015	
DWR Inspector	Bob Duffey		Bob Duffey	
Accompanied By	Bill Carriere		Bill Carriere	
			Jason Enos

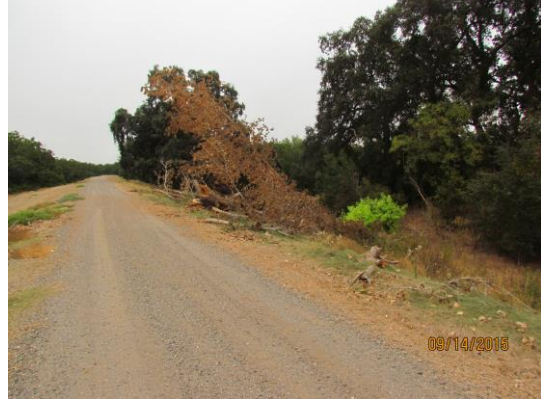
Photo 1 of 1 : FA_2015_LD0001G_432_41_20151013_00050.jpg

View of the tree on the waterside slope.

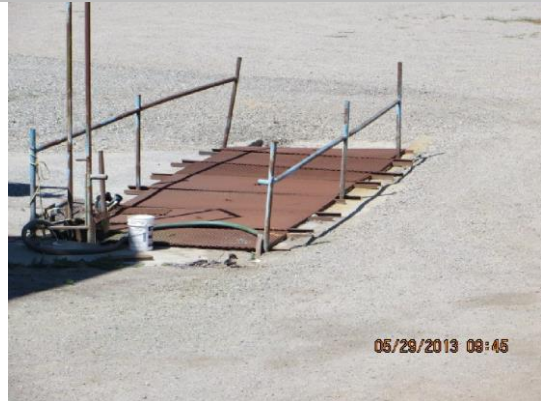
Photo 1 of 3 : UCIP_FA_2015_0953.jpg

LM Start	0.76	Rating **	M	Issue No.	396
LM End	0.76	Issue Type +	En	Location *	WS
Category	Supplemental			GPS Latitude/Longitude	
				Start	End
Item	DWR UCIP Field Study			39.487806 °	39.487806 °
				-122.019414 °	-122.019414 °
DWR ID					
Action/Comments					
Inspector Comments: FS_ID:14324 DS_ID:22893 EP_NO: 11782 FS_HLM: 0.79 Repair Type: Non-Urgent Crossing Status: Found UCIP Comments: Siphon breaker missing from WS shoulder. FIELD_STRUCT_DESC: 3-inch pipe through levee 2.0 feet below crown. Hose bib style siphon breaker on WS shoulder. Pipe runs from concrete sump next to barn on LS to cesspool off WS toe (Permit No. 11782, 1977). FS Date: 05/29/2013

Concrete sump next to barn off LS toe.

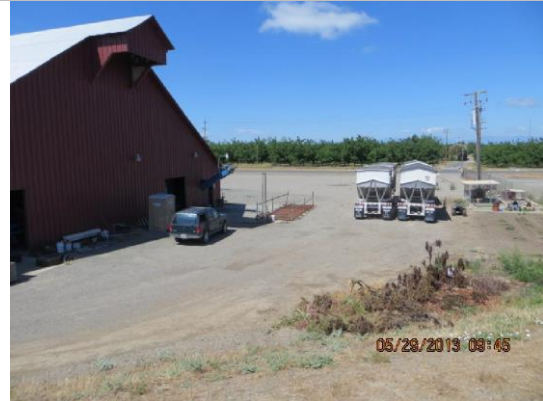
Photo 2 of 3 : UCIP_FA_2015_0954.jpg

Inspector Comments: FS_ID:14324
 DS_ID:22893
 EP_NO: 11782
 FS_HLM: 0.79
 Repair Type: Non-Urgent
 Crossing Status: Found
 UCIP Comments: Siphon breaker missing from WS shoulder.
 FIELD_STRUCT_DESC: 3-inch pipe through levee 2.0 feet below crown. Hose bib style siphon breaker on WS shoulder. Pipe runs from concrete sump next to barn on LS to cesspool off WS toe (Permit No. 11782, 1977).
 FS Date: 05/29/2013

Concrete sump next to barn off LS toe.

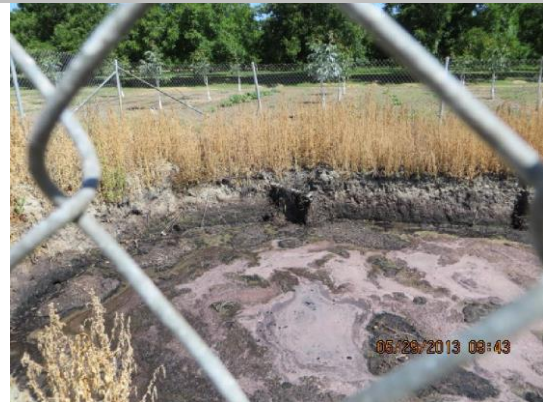
Photo 3 of 3 : UCIP_FA_2015_0955.jpg

3-inch pipe at cesspool off WS toe.

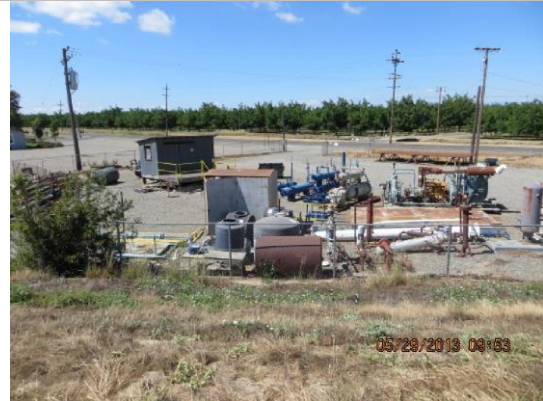
Photo 1 of 3 : UCIP_FA_2015_0956.jpg

LM Start	0.80	Rating **	M	Issue No.	397
LM End	0.80	Issue Type +	En	Location *	WS
Category	Supplemental			GPS Latitude/Longitude	
				Start	End
Item	DWR UCIP Field Study			39.488160 °	39.488160 °
				-122.019888 °	-122.019888 °
DWR ID					
Action/Comments					
Inspector Comments: FS_ID:14325					
DS_ID:22894					
EP_NO: 1837					
FS_HLM: 0.826					
Repair Type: Non-Urgent					
Crossing Status: Indicator Found

Gas pumping plant and appurtenances.

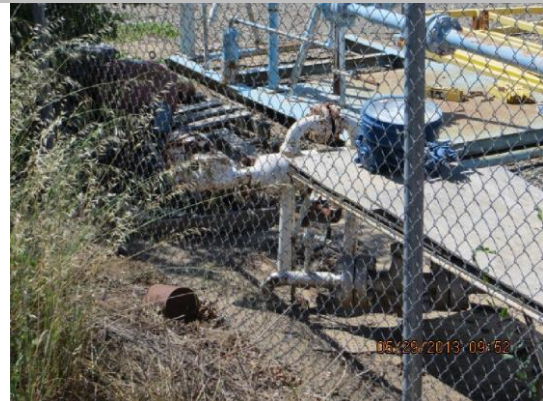
Photo 2 of 3 : UCIP_FA_2015_0957.jpg

Possible pipe at crossing, LS toe.

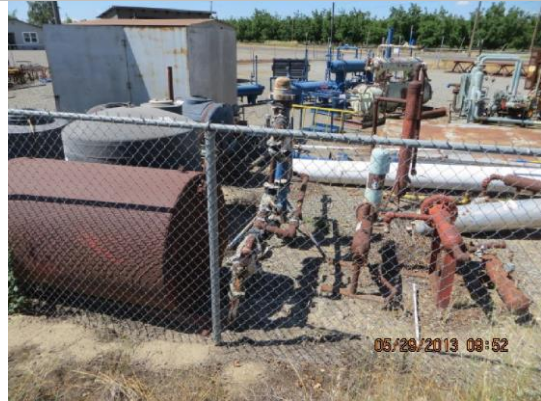
Photo 3 of 3 : UCIP_FA_2015_0958.jpg

LM Start	0.80	Rating **	M	Issue No.	397 (cont)
LM End	0.80	Issue Type +	En	Location *	WS
Category	Supplemental			GPS Latitude/Longitude	
				Start	End
Item	DWR UCIP Field Study			39.488160 °	39.488160 °
				-122.019888 °	-122.019888 °
DWR ID					
Action/Comments					
Inspector Comments: FS_ID:14325					
DS_ID:22894					
EP_NO: 1837					
FS_HLM: 0.826					
Repair Type: Non-Urgent					
Crossing Status: Indicator Found

Gas pumping plant and appurtenances.

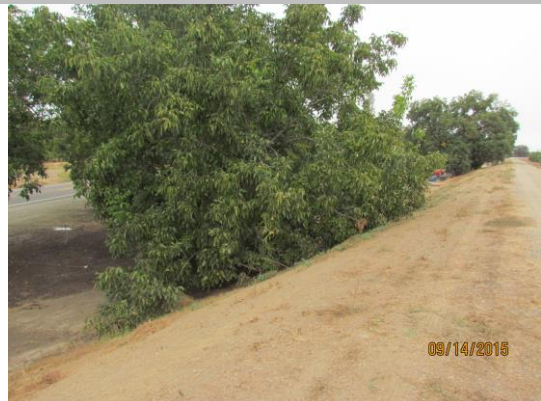
Photo 1 of 1 : FA_2015_LD0001G_432_43_20151013_00051.jpg

View of the tree limbs on the landside slope.

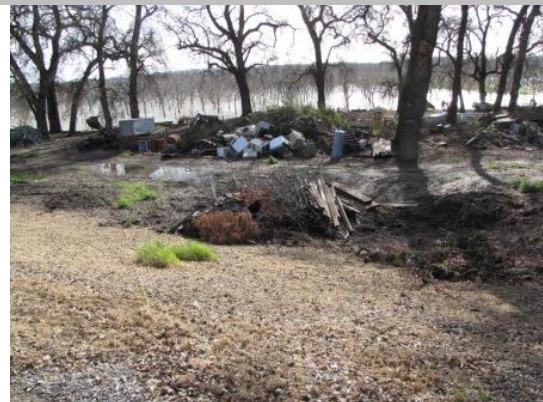
Photo 1 of 1 : FA_2015_LD0001G_432_1_20150910_00001.jpg

View of the debris & garbage along the W/S toe.

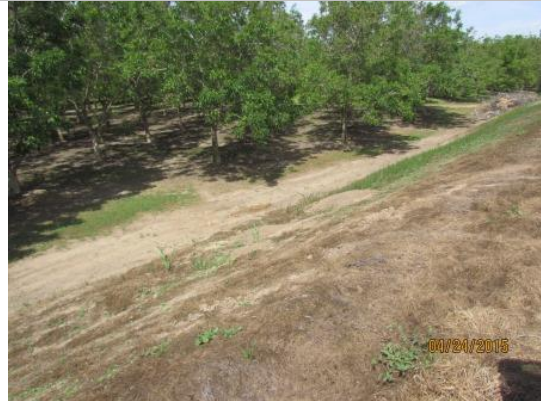
Photo 1 of 1 : FA_2015_LD0001G_432_59_20150910_00024.jpg

View of the rodent holes along the landside slope.

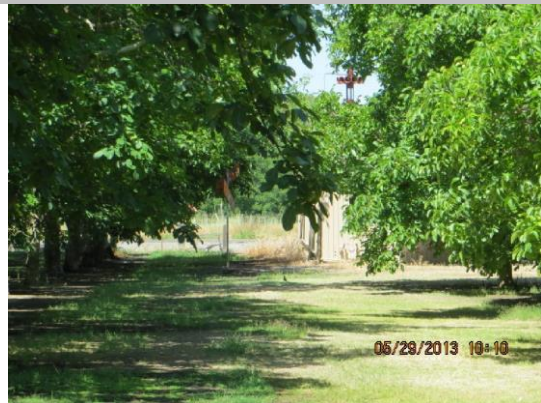
Photo 1 of 1 : UCIP_FA_2015_0959.jpg

LM Start	1.25	Rating **	M	Issue No.	399
LM End	1.25	Issue Type +	En	Location *	LS
Category	Supplemental			GPS Latitude/Longitude	
				Start	End
Item	DWR UCIP Field Study			39.493977 °	39.493977 °
				-122.018380 °	-122.018380 °
DWR ID					
Action/Comments					
Inspector Comments: FS_ID:14327					
DS_ID:22896					
EP_NO: 2171					
FS_HLM: 1.279					
Repair Type: Non-Urgent					
Crossing Status: Indicator Found					
UCIP Comments: Appears abandoned as well off LS toe has been removed. Need to remove from levee or mark as appropriate.					
FIELD_STRUCT_DESC: 2 of 2: 3-inch pipe through levee 2.0 feet below crown (Permit No. 2171, 1958). Abandoned gas-pump station 260-feet off LS toe.					
FS Date: 05/29/2013

Gasline markers near where removed pumping plant was located.

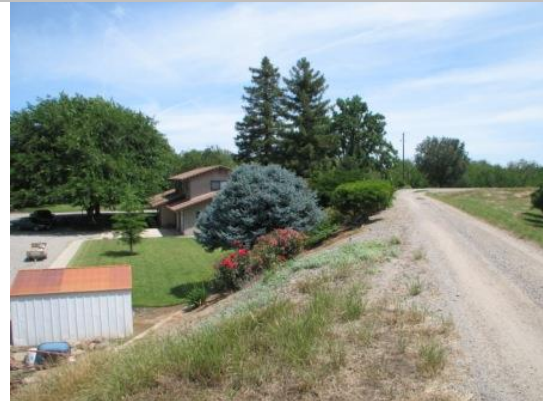
Photo 1 of 1 : FA_2015_LD0001G_432_6_20150910_00003.jpg

View of the permitted landscape on the landside slope of the levee.

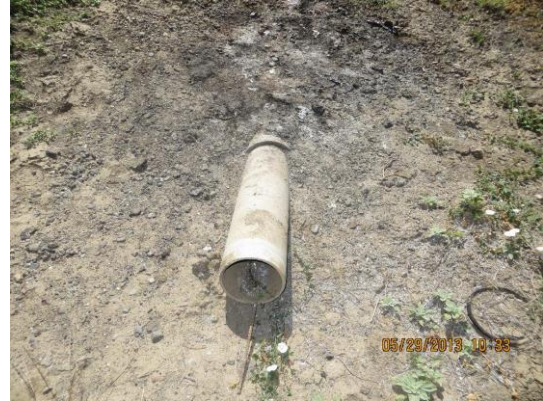
Photo 1 of 2 : UCIP_FA_2015_1032.jpg

Inspector Comments: FS_ID:14331
 DS_ID:22898
 EP_NO: 5717A
 FS_HLM: 2.26
 Repair Type: Non-Urgent
 Crossing Status: Found
 UCIP Comments: Pipe abandoned and should be done so properly.
 FIELD_STRUCT_DESC: 8-inch pipe sleeved through 12-inch though the levee 5-feet below the crown. Pump on landward side. Meter pole at landward toe, guy wire anchor in landward slope (Permit No. 5717A, 1969).
 FS Date: 05/29/2013

8-inch pipe visible at LS toe.

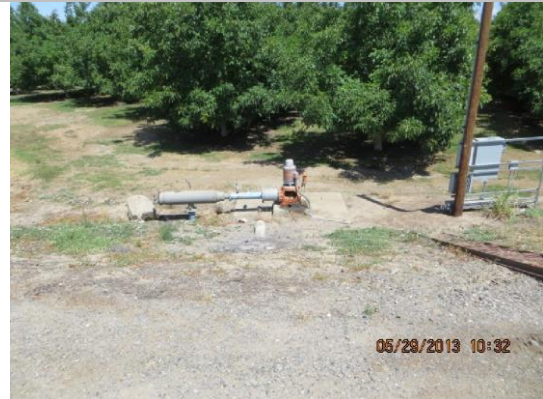
Photo 2 of 2 : UCIP_FA_2015_1033.jpg

Pump at LS toe with no connection to 8-inch pipe.

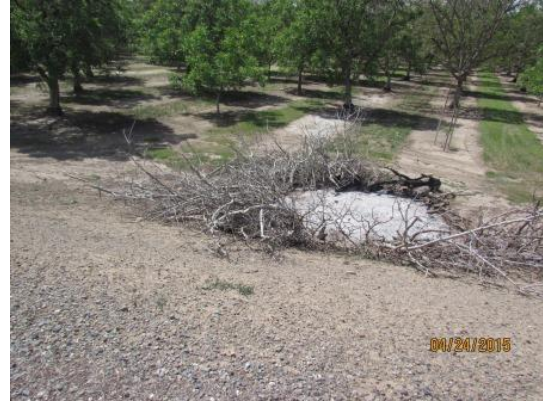
Photo 1 of 1 : FA_2015_LD0001G_432_61_20150910_00026.jpg

View of the prunings along the landside toe.

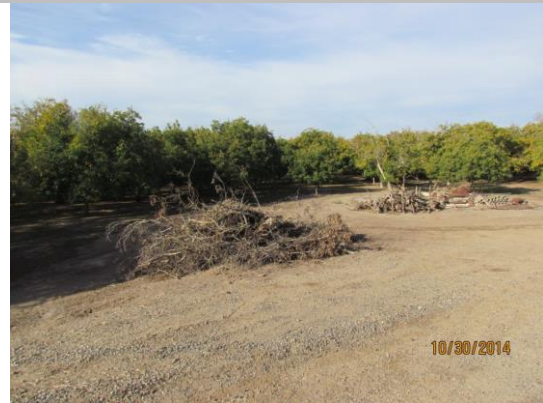
Photo 1 of 1 : FA_2015_LD0001G_432_49_20150910_00014.jpg

LM Start	2.80	Rating **	M	Issue No.	49
LM End	2.80	Issue Type +	En	Location *	LS
Category	Earthen Levee			GPS Latitude/Longitude	
				Start	End
Item	Encroachments			39.509503 °	39.509503 °
				-122.008732 °	-122.008732 °
DWR ID	DWR_LD0001G_01_f_2014_49				
Action/Comments					
Prunings

View of the prunings along the landsides toe.

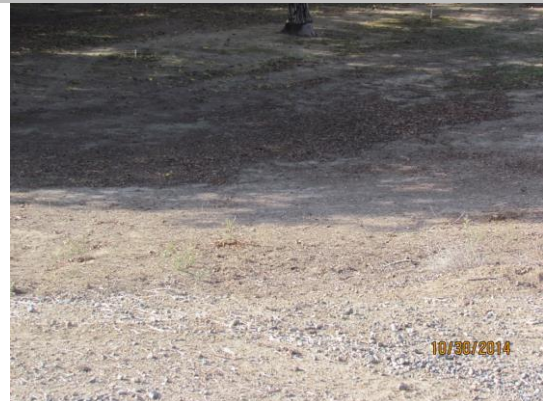
Photo 1 of 1 : FA_2015_LD0001G_432_50_20150910_00015.jpg

LM Start	2.80	Rating **	A/W	Issue No.	50
LM End	2.80	Issue Type +	Ma	Location *	LS
Category	Earthen Levee			GPS Latitude/Longitude	
				Start	End
Item	Animal Control			39.509503 °	39.509503
				-122.008732 °	-122.008732
DWR ID	DWR_LD0001G_01_f_2014_50				
Action/Comments					
No rodents visible, but rodent burrows visible; need to backfill and compact or grout burrows.

View of the rodent activity along the landside slope.

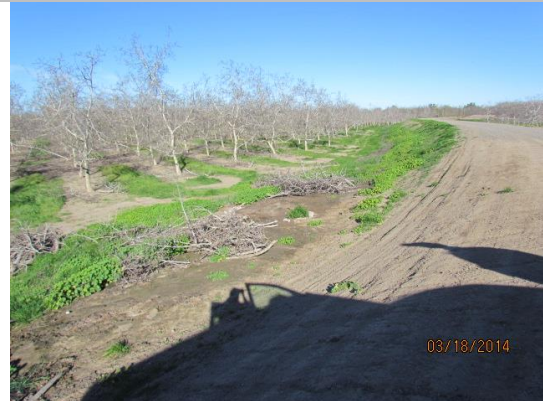
Photo 1 of 1 : FA_2015_LD0001G_432_45_20150910_00010.jpg

View of the removed prunings from the l/s slope.

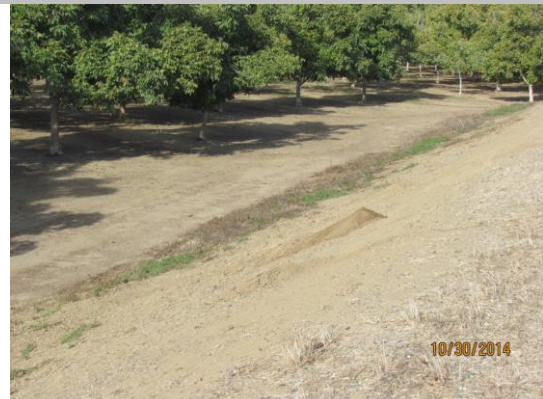
Photo 1 of 1 : FA_2015_LD0001G_432_51_20150910_00016.jpg

LM Start	3.09	Rating **	U	Issue No.	51
LM End	3.09	Issue Type +	Ma	Location *	LS
Category	Earthen Levee			GPS Latitude/Longitude	
				Start	End
Item	Animal Control			39.513485 °	39.513485 °
				-122.009593 °	-122.009593 °
DWR ID	DWR_LD0001G_01_f _ 2014_51				
Action/Comments					
No rodents visible, but rodent burrows visible; need to backfill and compact or grout burrows.

View of the rodent activity along the landside slope.

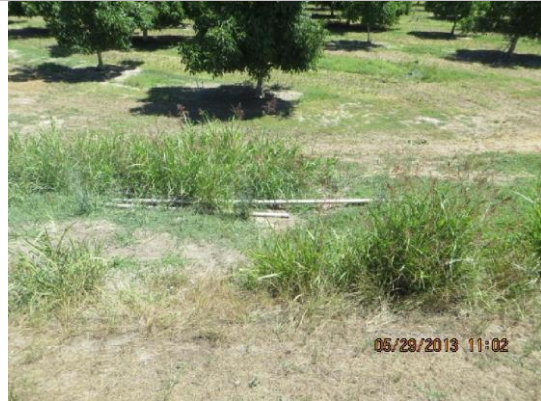
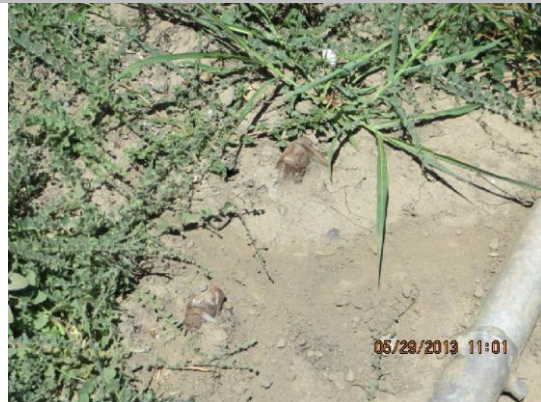
LM Start	3.13	Rating **	M	Issue No.	403
LM End	3.13	Issue Type +	En	Location *	LS
Category	Supplemental			GPS Latitude/Longitude	
				Start	End
Item	DWR UCIP Field Study			39.513835 °	39.513835 °
				-122.010029 °	-122.010029 °
DWR ID					
Action/Comments					
Inspector Comments: FS_ID:16223 DS_ID:22901 EP_NO: 9575 FS_HLM: 3.181 Repair Type: Non-Urgent Crossing Status: Found UCIP Comments: Appears to have been abandoned. Need to verify pipe was grouted/abandoned properly. FIELD_STRUCT_DESC: 12-inch pipe through levee 14.0 feet below crown. Flap Gate on waterward end (ABO No. 9575, 1974). FS Date: 05/29/2013

Flap gate visible at WS toe.

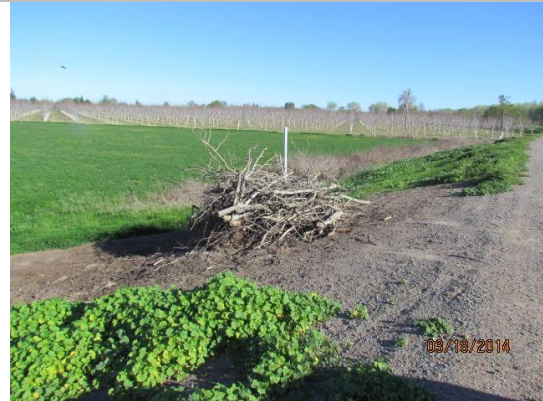
Photo 1 of 1 : FA_2015_LD0001G_432_46_20150910_00011.jpg

View of the prunings along the landside slope.

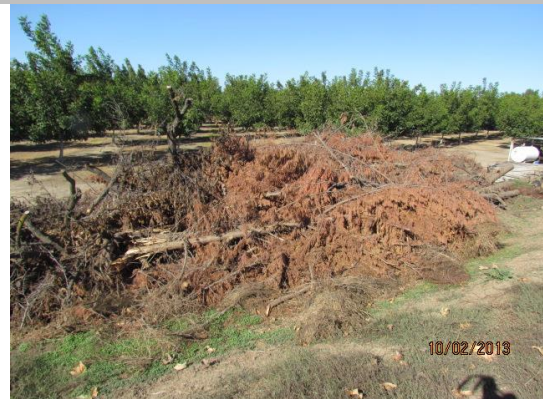
Photo 1 of 1 : FA_2015_LD0001G_432_56_20150910_00021.jpg

LM Start	3.63	Rating **	M	Issue No.	56
LM End	3.63	Issue Type +	En	Location *	LS
Category	Earthen Levee			GPS Latitude/Longitude	
				Start	End
Item	Encroachments			39.520623 °	39.520623 °
				-122.010457 °	-122.010457 °
DWR ID	DWR_LD0001G_01_f _ 2013_56				
Action/Comments					
Prunings

View of the prunings & limbs along the slope of the levee.

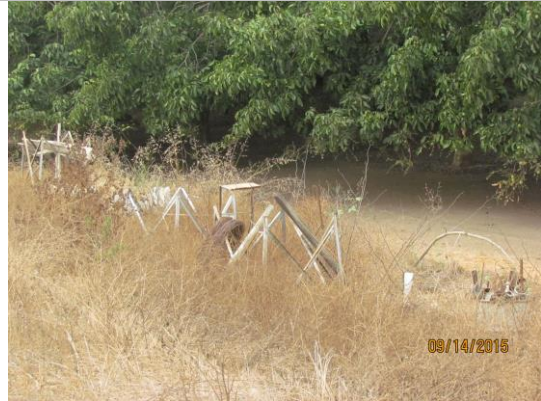
Photo 1 of 1 : FA_2015_LD0001G_432_23_20151013_00052.jpg

View of the equipment along the landside toe.

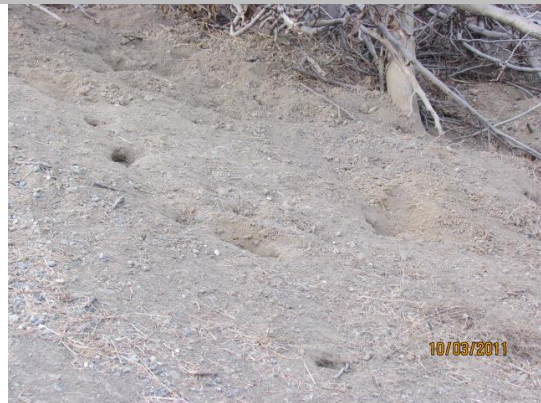
Photo 1 of 1 : FA_2015_LD0001G_432_395_20150910_00028.jpg

LM Start	3.88	Rating **	U	Issue No.	395
LM End	3.88	Issue Type +	Ma	Location *	LS
Category	Earthen Levee			GPS Latitude/Longitude	
				Start	End
Item	Animal Control			39.523845 °	39.523845 °
				-122.010745 °	-122.010745 °
DWR ID	DWR_LD0001G_01_s _ 2012_395				
Action/Comments					
No rodents visible, but rodent burrows visible; need to backfill and compact or grout burrows.					
Inspector Comments: Repair the rodent hole on the landside slope.

View of the rodent holes along the L/S toe.

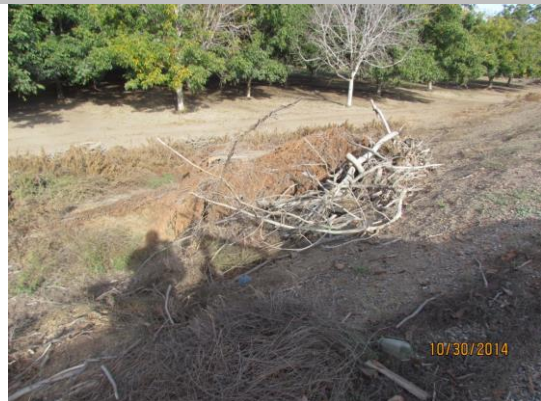
Photo 1 of 1 : FA_2015_LD0001G_432_52_20150910_00017.jpg

View of the prunings along the landside toe.

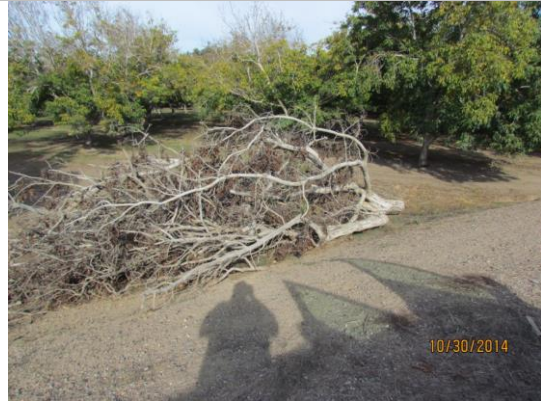
Photo 1 of 1 : FA_2015_LD0001G_432_53_20150910_00018.jpg

View of the prunings along the landside toe.

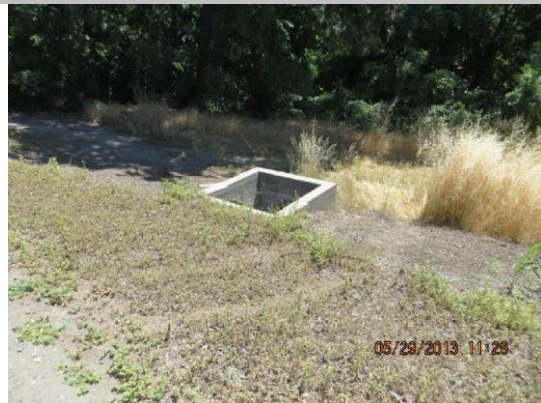
Photo 1 of 3 : UCIP_FA_2015_0536.jpg

LM Start	3.98	Rating **	U	Issue No.	404
LM End	3.98	Issue Type +	En	Location *	LS
Category	Supplemental			GPS Latitude/Longitude	
				Start	End
Item	DWR UCIP Field Study			39.524990 °	39.524990 °
				-122.009575 °	-122.009575 °
DWR ID					
Action/Comments					
Inspector Comments: FS_ID:16243 DS_ID:22904 EP_NO: 9572 FS_HLM: 4.045 Repair Type: Urgent Crossing Status: Found UCIP Comments: Broken flap gate and Concrete headwall on LS toe possibly tilting. Also a 3-inch alluminum irrigation line through the pipe. FIELD_STRUCT_DESC: 18-inch pipe through levee 7.3 feet below crown. Flap gate in 6'X6' concrete box on waterward end. Concrete bulkhead at landward toe (ABO No. 9572, 1974). Originally included in the 1960 O&M manual. FS Date: 05/29/2013

Distribution box on WS toe.

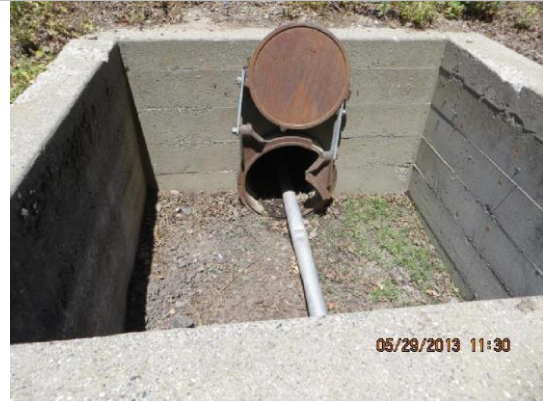
Photo 2 of 3 : UCIP_FA_2015_1452.jpg

Inspector Comments: FS_ID:16243
DS_ID:22904
EP_NO: 9572
FS_HLM: 4.045
Repair Type: Urgent
Crossing Status: Found
UCIP Comments: Broken flap gate and Concrete headwall on LS toe possibly tilting. Also a 3-inch alluminum irrigation line through the pipe.
FIELD_STRUCT_DESC: 18-inch pipe through levee 7.3 feet below crown. Flap gate in 6'X6' concrete box on waterward end. Concrete bulkhead at landward toe (ABO No. 9572, 1974). Originally included in the 1960 O&M manual.
FS Date: 05/29/2013

Distribution box on WS toe with broken flap gate and 3-inch aluminum irrigation pipe.

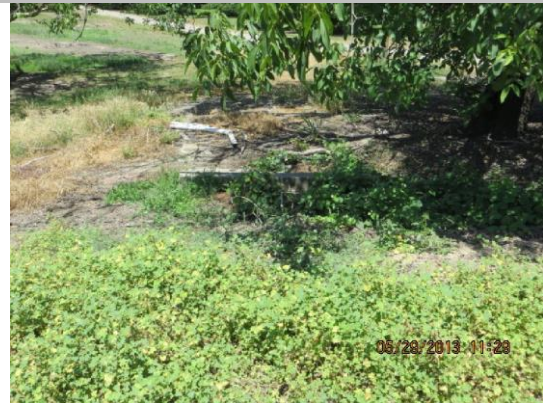
Photo 3 of 3 : UCIP_FA_2015_1453.jpg

Headwall on LS toe.

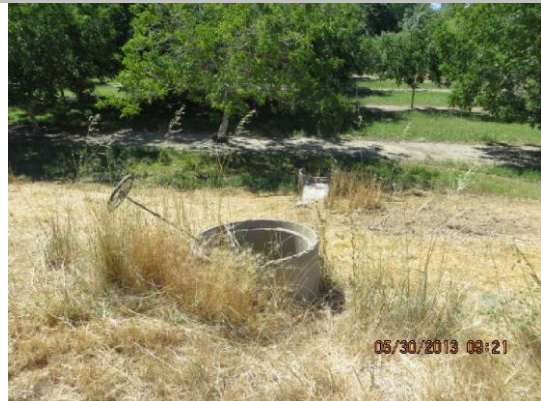
Photo 2 of 3 : UCIP_FA_2015_1038.jpg

LM Start	4.25	Rating **	U	Issue No.	405
LM End	4.25	Issue Type +	En	Location *	LS
Category	Supplemental			GPS Latitude/Longitude	
				Start	End
Item	DWR UCIP Field Study			39.527050 °	39.527050 °
				-122.005247 °	-122.005247 °
DWR ID					
Action/Comments					
Inspector Comments: FS_ID:14343					
DS_ID:22906					
EP_NO: 1229					
FS_HLM: 4.322					
Repair Type: Urgent					
Crossing Status: Found

Gate valve in Concrete riser on WSs houlder.

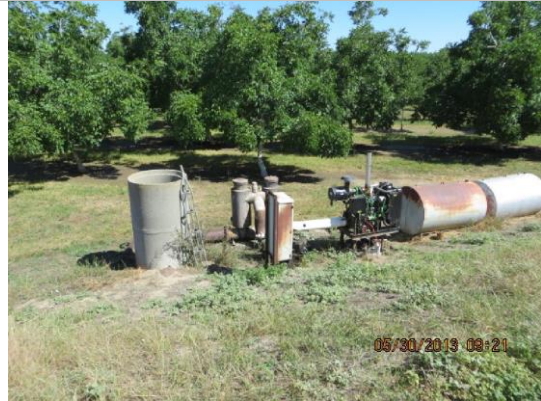
Photo 3 of 3 : UCIP_FA_2015_1039.jpg

LM Start	4.25	Rating **	U	Issue No.	405 (cont)	
LM End	4.25	Issue Type +	En	Location *	LS	
Category	Supplemental			GPS Latitude/Longitude		
				Start		End
Item	DWR UCIP Field Study			39.527050 °		39.527050 °
				-122.005247 °		-122.005247 °
DWR ID						
Action/Comments						
Inspector Comments: FS_ID:14343						
DS_ID:22906						
EP_NO: 1229						
FS_HLM: 4.322						
Repair Type: Urgent						
Crossing Status: Found

Pump, standpipe, and gate valve on LS toe.

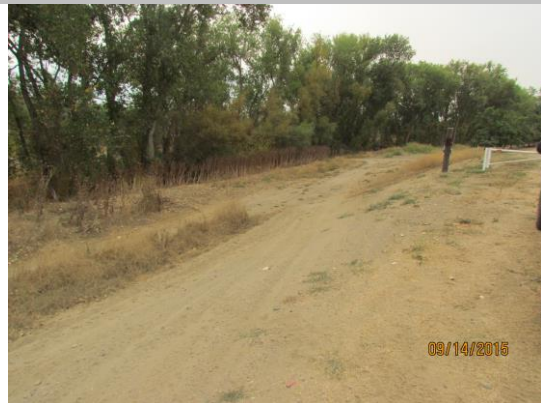
Photo 1 of 1 : FA_2015_LD0001G_432_63_20151013_00053.jpg

LM Start	4.93	Rating **	M	Issue No.	63
LM End	4.93	Issue Type +	Ma	Location *	WS
Category	Earthen Levee			GPS Latitude/Longitude	
				Start	End
Item	Slope Stability			39.532719 °	39.532719
				-121.995849 °	-121.995849
DWR ID	DWR_LD0001G_01_f_2015_63				
Action/Comments					
Repair the levee slope damaged by vehicle traffic and prevent access where possible.					
Inspector Comments: Repair the erosion along the waterside slope.

View of the vehicle erosion along the waterside slope.

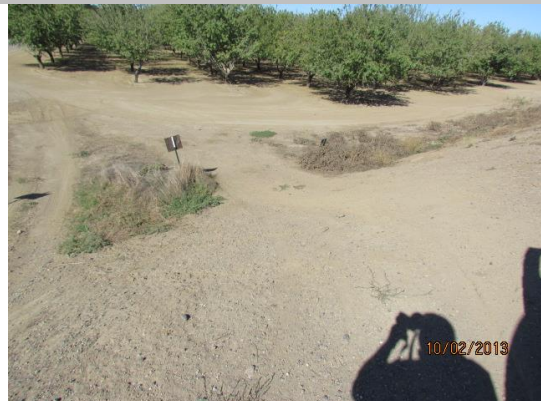
Photo 1 of 1 : FA_2015_LD0001G_432_57_20150910_00022.jpg

LM Start	5.06	Rating **	M	Issue No.	57
LM End	5.06	Issue Type +	Ma	Location *	LS
Category	Earthen Levee			GPS Latitude/Longitude	
				Start	End
Item	Slope Stability			39.534593 °	39.534593 °
				-121.995950 °	-121.995950 °
DWR ID	DWR_LD0001G_01_f_2013_57				
Action/Comments					
Repair the levee slope damaged by vehicle traffic and prevent access where possible.

View of the vehicle erosion along the slope of the levee.

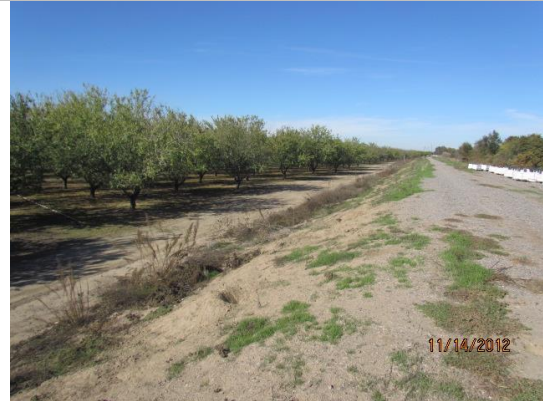
Photo 1 of 1 : FA_2015_LD0001G_432_7_20150910_00004.jpg

View of the rodent hole along the levee slope.

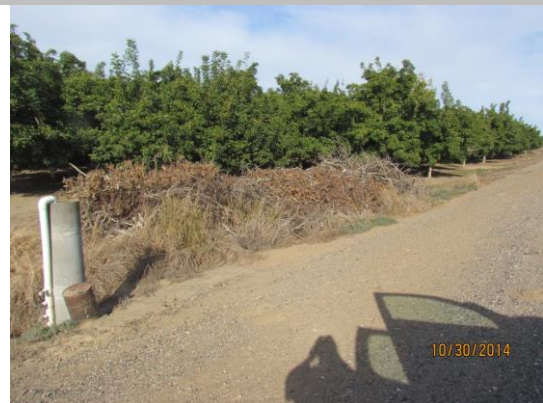
Photo 1 of 1 : FA_2015_LD0001G_432_54_20150910_00019.jpg

View of the prunings along the landside toe.

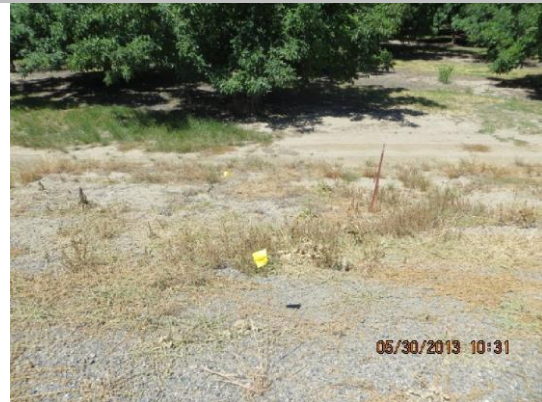
Photo 2 of 2 : UCIP_FA_2015_1041.jpg

LM Start	6.18	Rating **	M	Issue No.	406
LM End	6.18	Issue Type +	En	Location *	LS
Category	Supplemental			GPS Latitude/Longitude	
				Start	End
Item	DWR UCIP Field Study			39.549911 °	39.549911 °
				-122.002102 °	-122.002102 °
DWR ID					
Action/Comments					
Inspector Comments: FS_ID:14352 DS_ID:22911 EP_NO: 5118 FS_HLM: 6.274 Repair Type: Non-Urgent Crossing Status: Indicator Found UCIP Comments: New gasline markers should be installed as existing signage has been sun faded FIELD_STRUCT_DESC: 1 of 2: 12.75-inch high pressure gas line through levee 3.0 feet below crown (Permit No. 5118, 1965). FS Date: 05/30/2013

Gasline flags on LS slope.

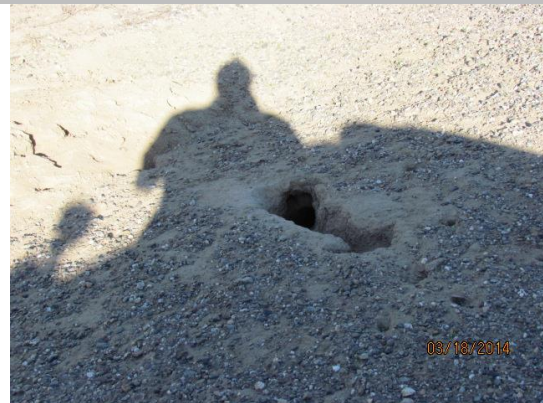
Photo 1 of 1 : FA_2015_LD0001G_432_47_20150910_00012.jpg

View of the rodent activity along the l/s slope.

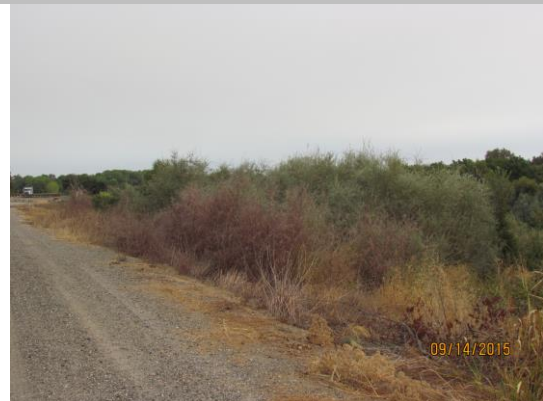
Photo 1 of 1 : FA_2015_LD0001G_432_65_20151013_00054.jpg

View of the vegetation along the waterside slope and toe.

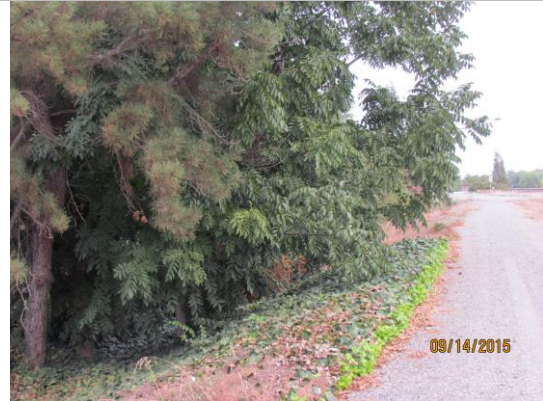
Photo 1 of 1 : FA_2015_LD0001G_432_64_20151013_00055.jpg

View of the trees along the landside toe.

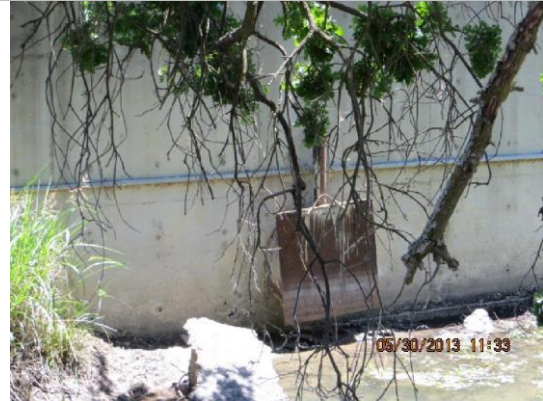
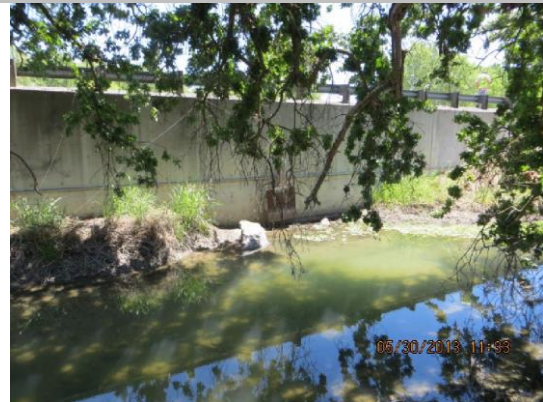
Pipe with steel plate welded over end on LS of levee crown.

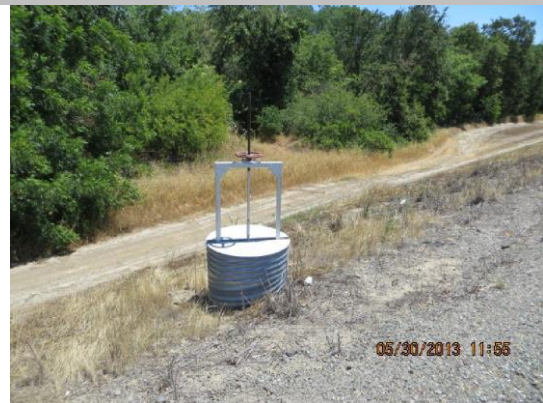
Photo 2 of 3 : UCIP_FA_2015_1109.jpg

Slide gate in 36-inch CMP standpipe on WS slope

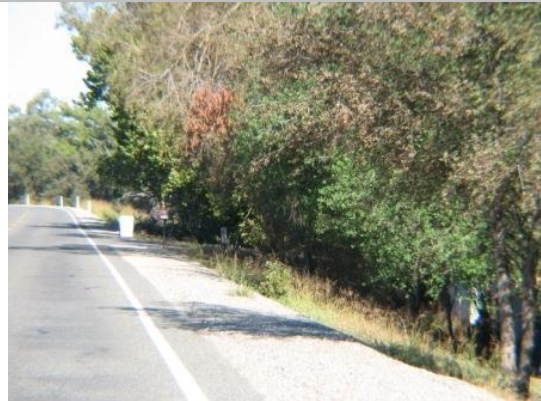
Photo 1 of 1 : FA_2015_LD0001G_432_20_20150910_00009.jpg

View of the trees and vegetation along the waterside slope of the levee.

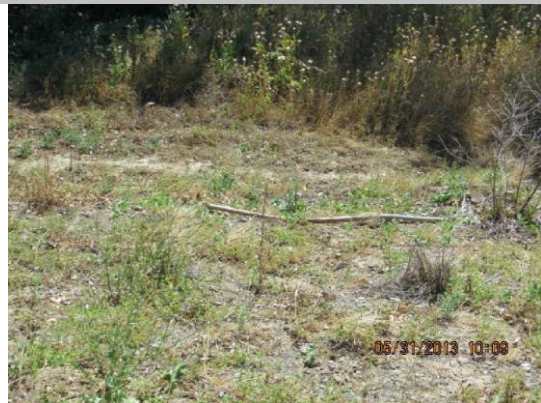
Photo 1 of 3 : UCIP_FA_2015_1410.jpg

Pipe debris on WS slope may be indicator of pipe location on WS.

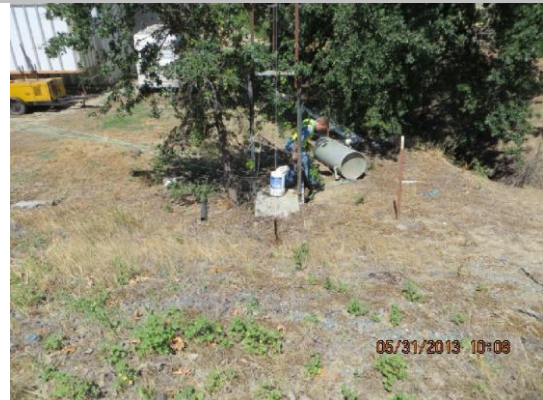
Photo 3 of 3 : UCIP_FA_2015_1412.jpg

Pipe visible next to well with bucket over standpipe.

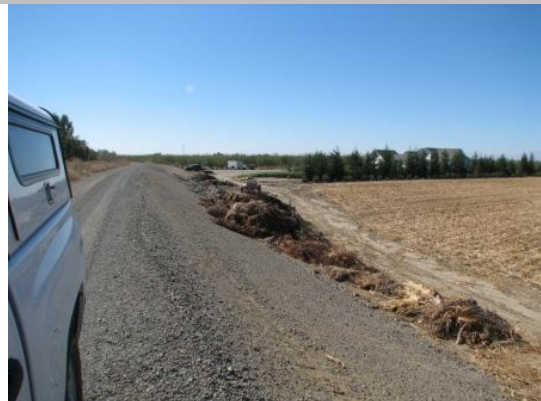
Photo 1 of 1 : FA_2015_LD0001G_432_11_20150910_00007.jpg

View of debris along the toe of the levee.

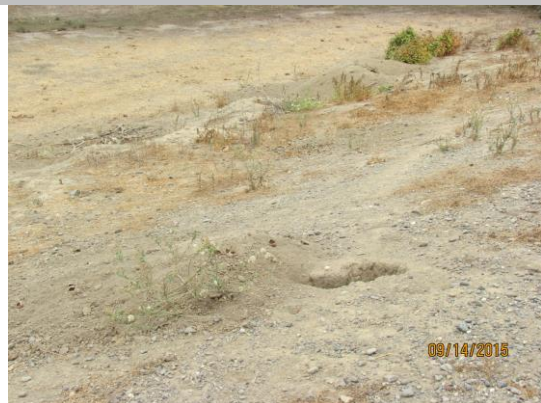
Photo 1 of 1 : FA_2015_LD0001G_432_66_20151013_00057.jpg

View of the rodent holes along the waterside slope.

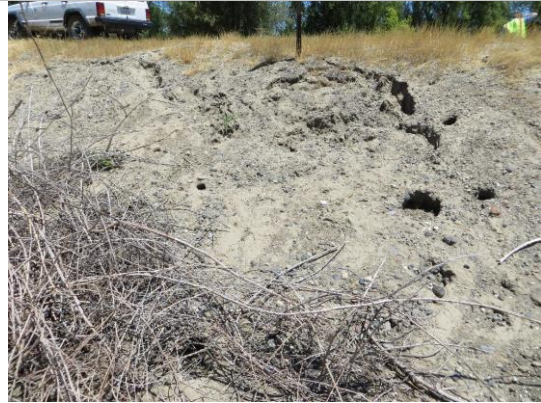
Photo 1 of 3 : UCIP_FA_2015_0961.jpg

Erosion and sloughing on LS slope possibly due to rodent activity.
